EMERGING TECHNOLOGY

Advances and innovations affecting design and construction

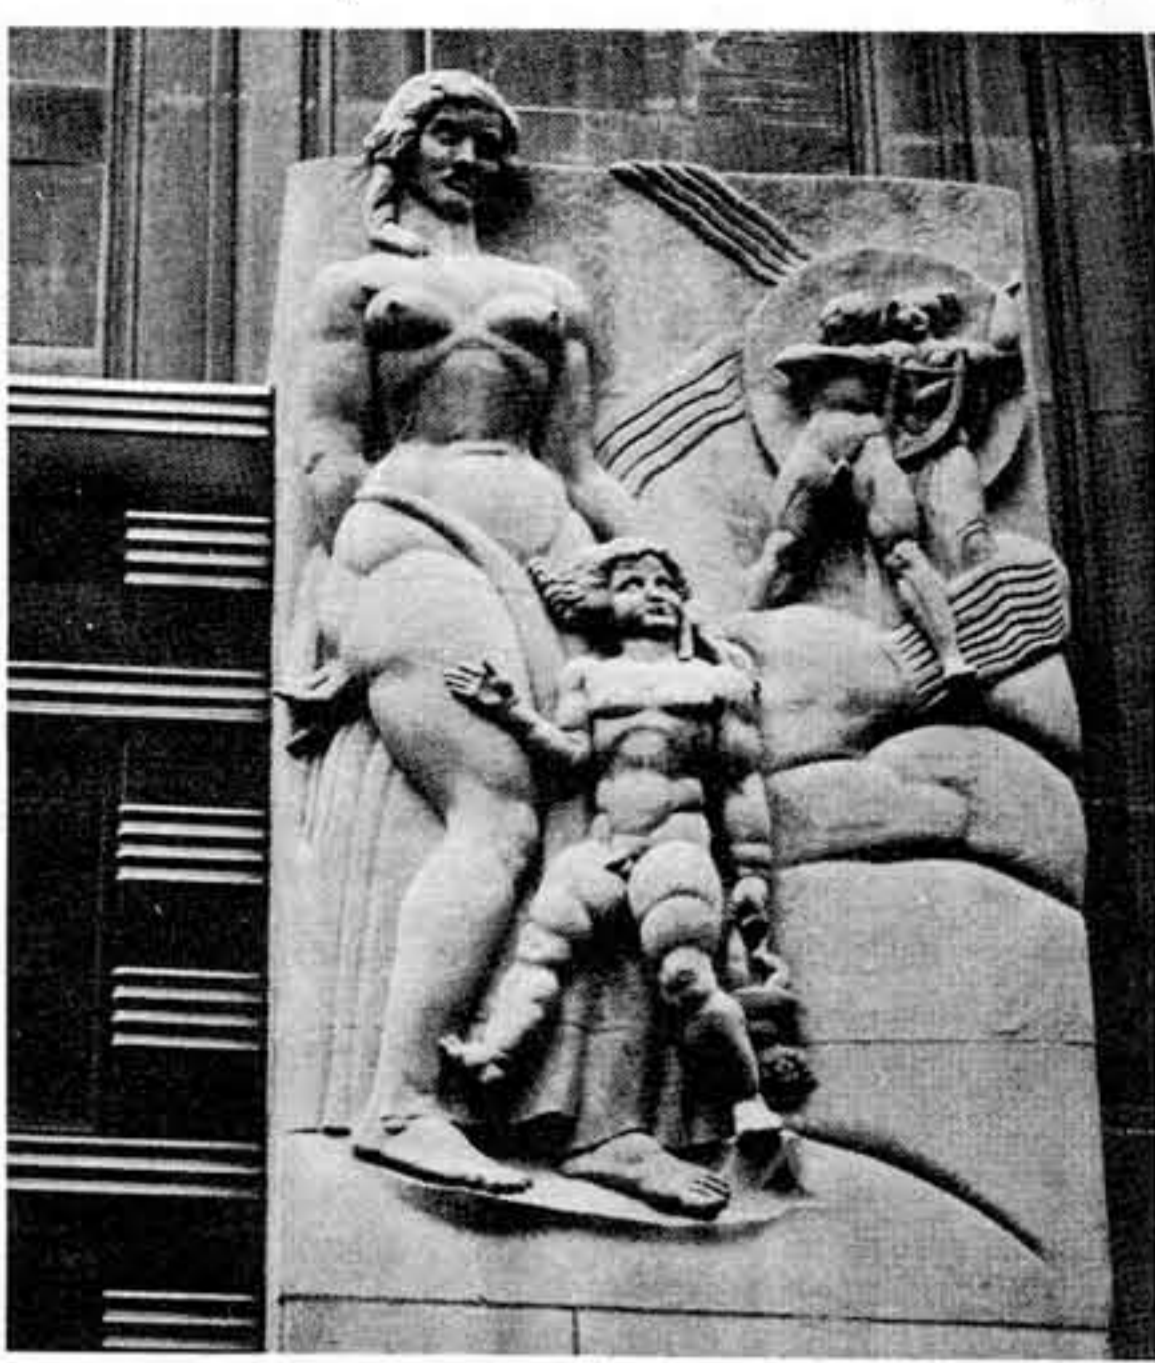
The maintenance and restoration of limestone facades on the 60-year-old Rockefeller Center include the repair of both sculptures (foreground) and thick ashlar panels (background). Photo: Cathedral Stoneworks
